Food Safety Kaizen Sheet

Barry Callebaut Cocoa & Chocolate Ingredients Pvt Ltd

Kaizen Title: Malfunctioning of Metal detector in case of low air pressure supply

Implementation Area:
 Metal Detector – Final Packaging Area– BAKING LINE

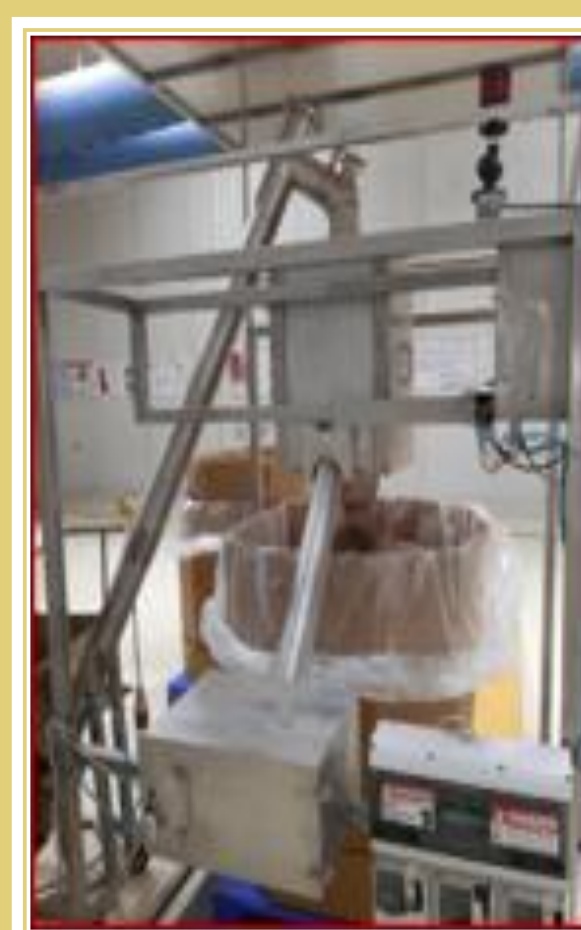
BEFORE

Problem Statement with Status: Malfunctioning of metal detector in case of low air pressure, metal contaminated product can pass into finish good.

1. Separation Flap stops immediately in the last position
2. In case of air pressure drop less than specified limit(3.5Bar), the equipment & Separation flap stops working at the existing position
3. There is no any control / system to keep separation flap to decide separation flap position in case of pressure drop.

Root Cause: There is no any control/system to keep separation flap position synchronize with air pressure system in case of air pressure drops.

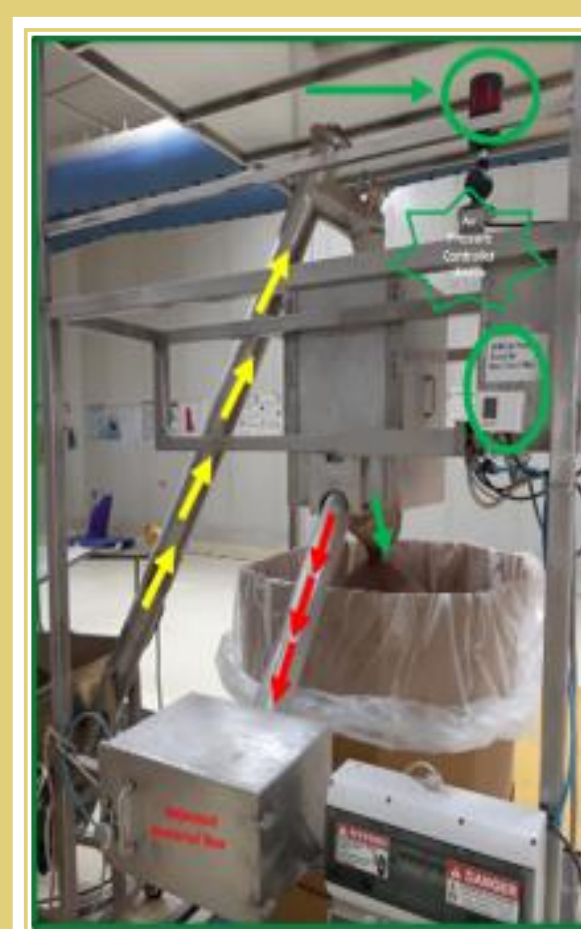
AFTER

Automatic air pressure control switch to be synchronized with the Gravity fall metal detector, which will work in the way that, in case of air pressure drops below 3.5 Bar, the separation flap will reject all the material till air pressure comes to required level. Parallely the Buzzer and alarm lamp will be active at the station.

What: Verification of air pressure interlock system to be done every day
